# **Christchurch City Council**

## **Stopbank Levees Risk Assessment**

September 2016

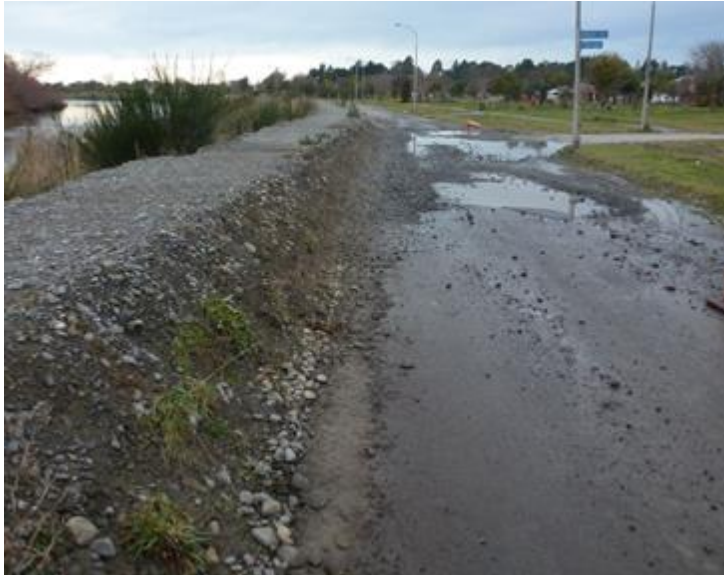
**Figure 3-6** Photograph of Typical Levee Section 15

Geogrid, Triax TX160, and Bidim Geofabric has been used in some areas, particularly those with poor founding conditions. Sandbags have been used at several locations including Owles Terrace and New Brighton Road where the width of the stopbank was narrow owing to space constraints. Working in conjunction with CCC's arborists, significant trees have been protected from the new stopbank fill material.

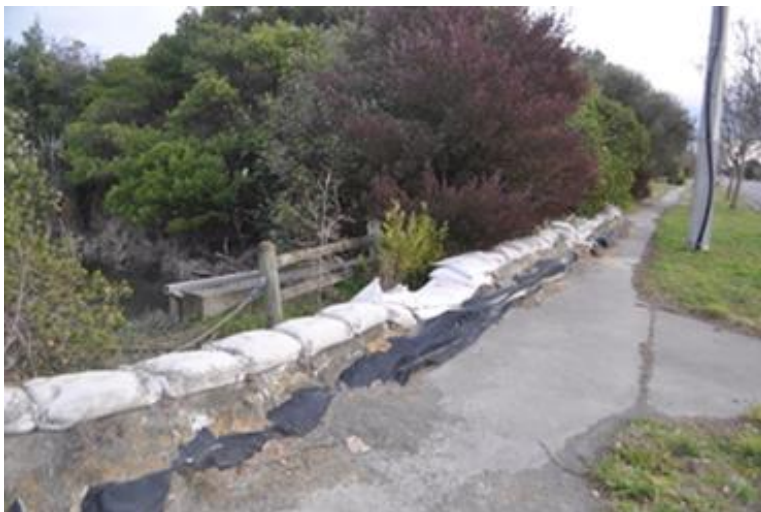
**Figure 3-24 Section 6 – Left Bank – Example of Sandbags**

In some areas, the land area was limited and sandbags were used to form the levee as shown in Figure 3-24 below. The degradation of these sandbags has been considered in the risk assessment.

- Reinststate the stopbank levels to the design level of RL 11.2 m
- Replace or upgrade the sandbag sections 6, 7, 8 and 12 with a conventional gravel section.
