# **Christchurch City Council**

## **Stopbank Levees Risk Assessment**

September 2016

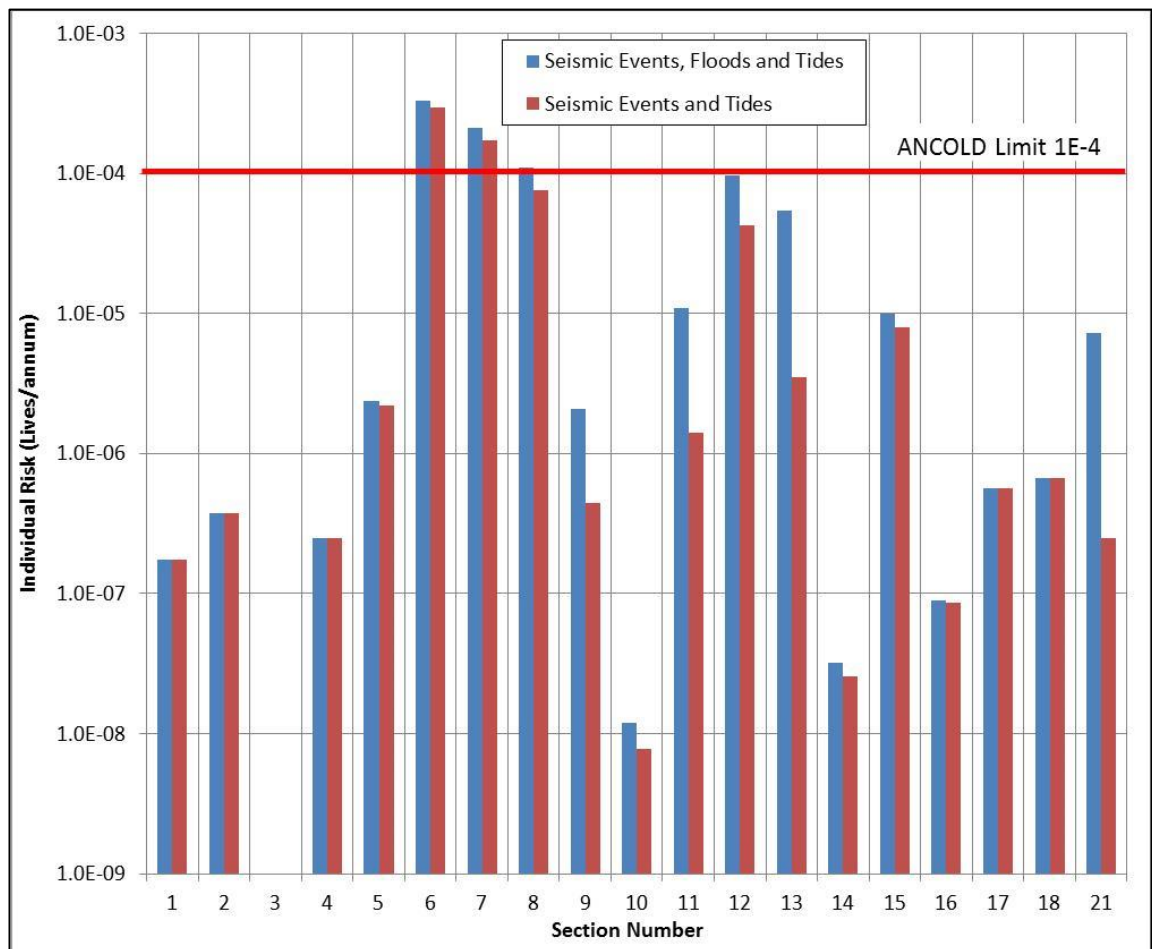
### Avon Stopbanks Individual Risks above or close to the ANCOLD limit of Tolerability

The results clearly show that the individual risk for the Avon Stopbanks is above the tolerable limit of 1.0E-4 lives/annum as shown on following figure and summarised on the table below.

Section	Tides and Seismic events	Tides, Floods and Seismic Events
Section 6	2.95 E-4	3.28E-4
Section 7	1.73E-4	2.13E-4
Section 8	7.57E-5	1.10E-4
Section 12	4.26E-5	9.70E-5

- Reinststate the stopbank levels to the design level of RL 11.2 m
- Replace or upgrade the sandbag sections 6, 7, 8 and 12 with a conventional gravel section.

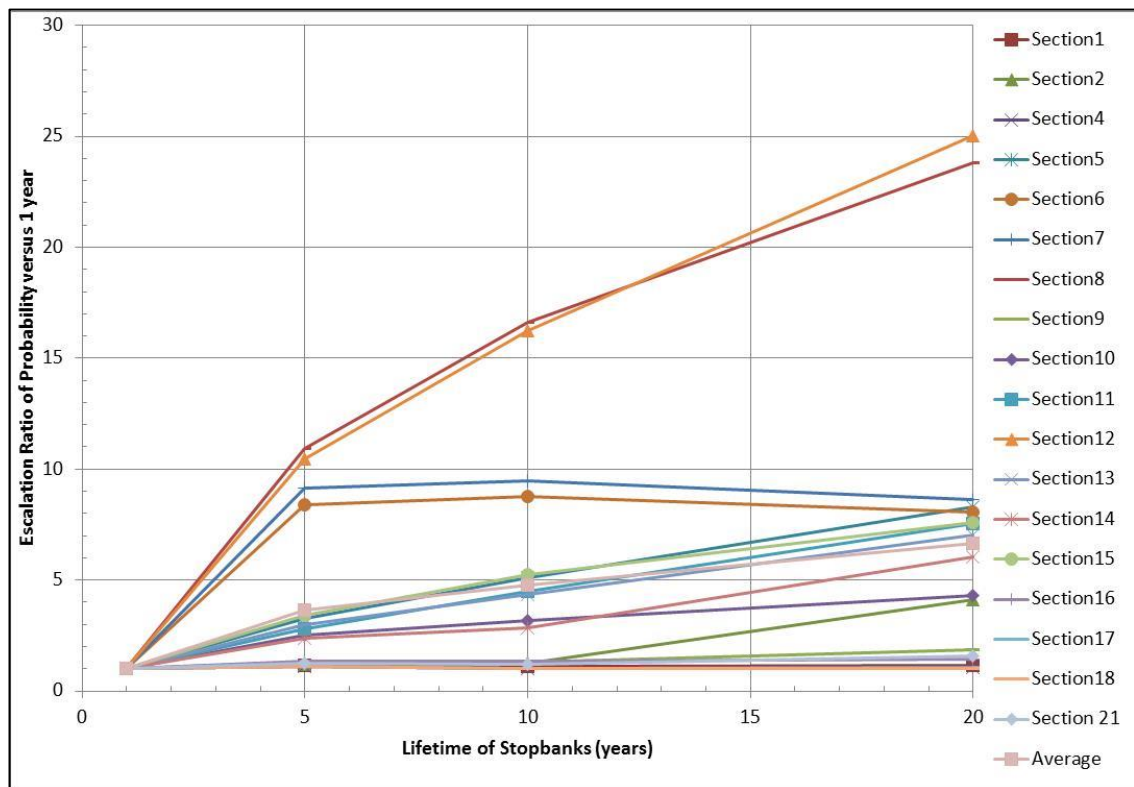
### Avon Stopbanks Escalation factors for probability of failure during lifetime

The results show a significant escalation in potential failure of the stopbank sections within the next five years, as shown on the figure below of between 8 to 11 for Sections 6, 7, 8 and 12 where sandbags have been used for tidal protection. Section 2, which also has sand bags, has a lower increase of about 1.2 owing to the use of the more substantial sandbags combined with earthfill at this section. The overall increase in failure potential is 3.66 times the annual failure probability within the next 5 years of operation.

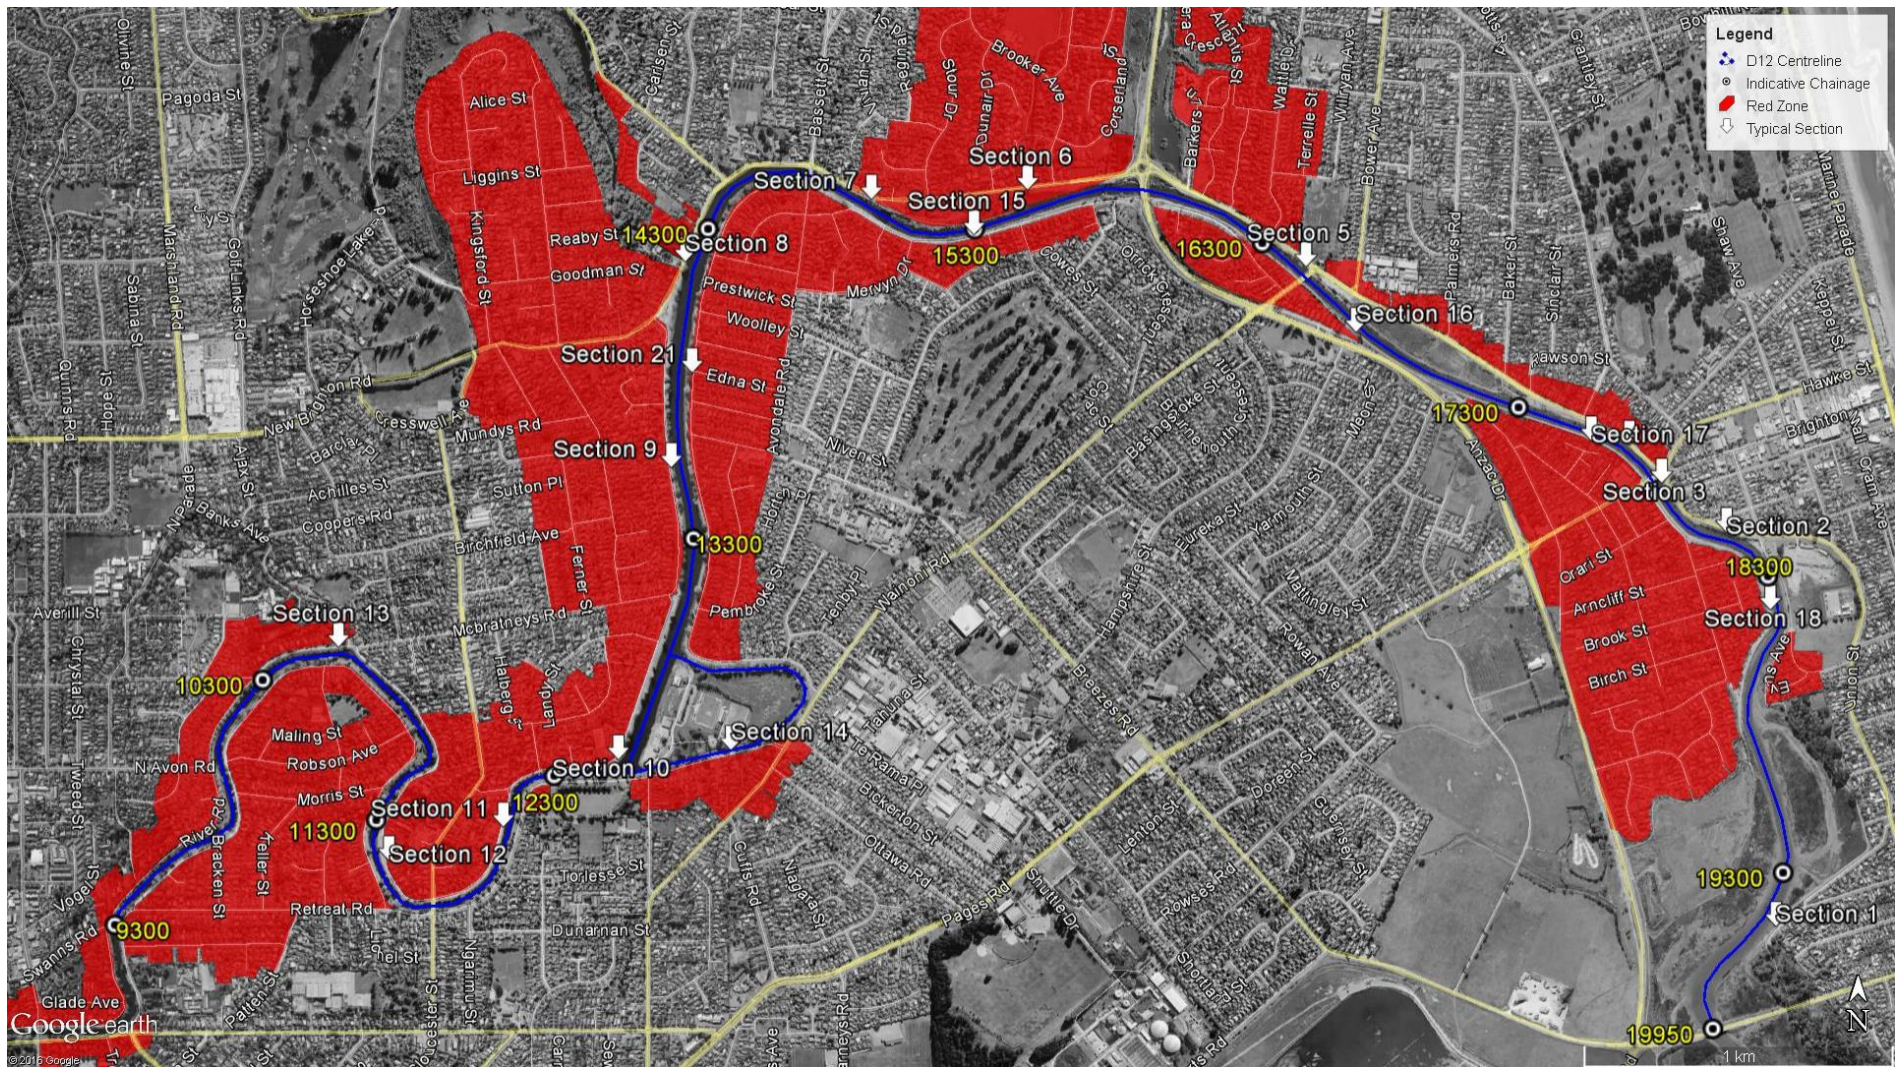
**Figure 3-4 Indicative Section Locations Assessed as Part of the Risk Assessment (red zone properties)**

The purpose of the site inspection was to evaluate the condition of stopbanks and identify typical sections for the risk analysis. The sections selected are shown on Figure 3-4.

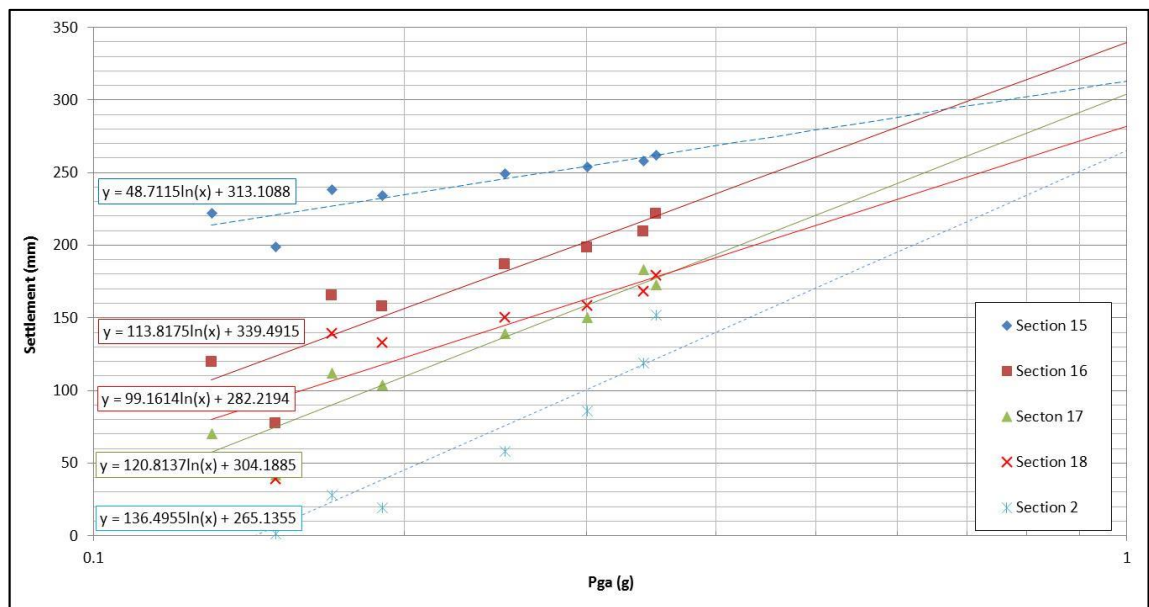
**Figure 3-7 Avon Stopbanks typical deformation analysis results**

The deformation results were used to estimate the likely crest settlement at each selected cross section from which to evaluate the overtopping potential given tidal fluctuations.

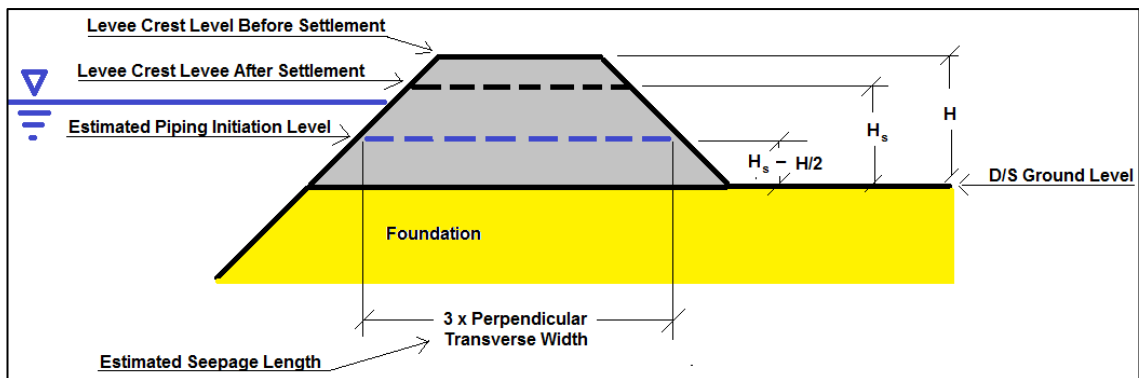
**Figure 3-20 Schematic section showing the estimation of Hydraulic Gradient Initiating Piping**

The hydraulic gradients used to assess the likelihood of piping through the embankment where cracks are initiated were calculated for a range of partition levels. Following the seismic events, cracks were observed at various locations along the levee alignment on both the left and right banks. These cracks were mapped and can be found in Appendix C. Transverse cracks were generally observed to be diagonal to axis of the levee rather than perpendicular hence the seepage length was taken as three times the transverse width (perpendicular to the axis of the levee). The estimated piping initiation level was taken as the levee crest level after settlement (initiated by seismic loading) minus half of the original height of the levee. This information is shown schematically in Figure 3-20 below.

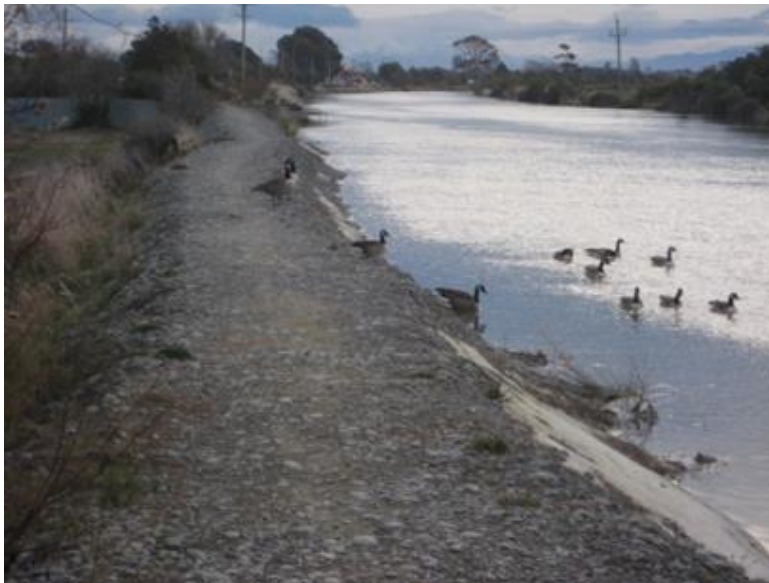
**Figure 3-23 Section 17 Right Bank – Typical gravel fill Stopbank**

The Avon stopbank levees have been constructed with gravel fill material, which is erodible hence with sufficient depth and velocity of overtopping flow, erosion of the levee could occur.

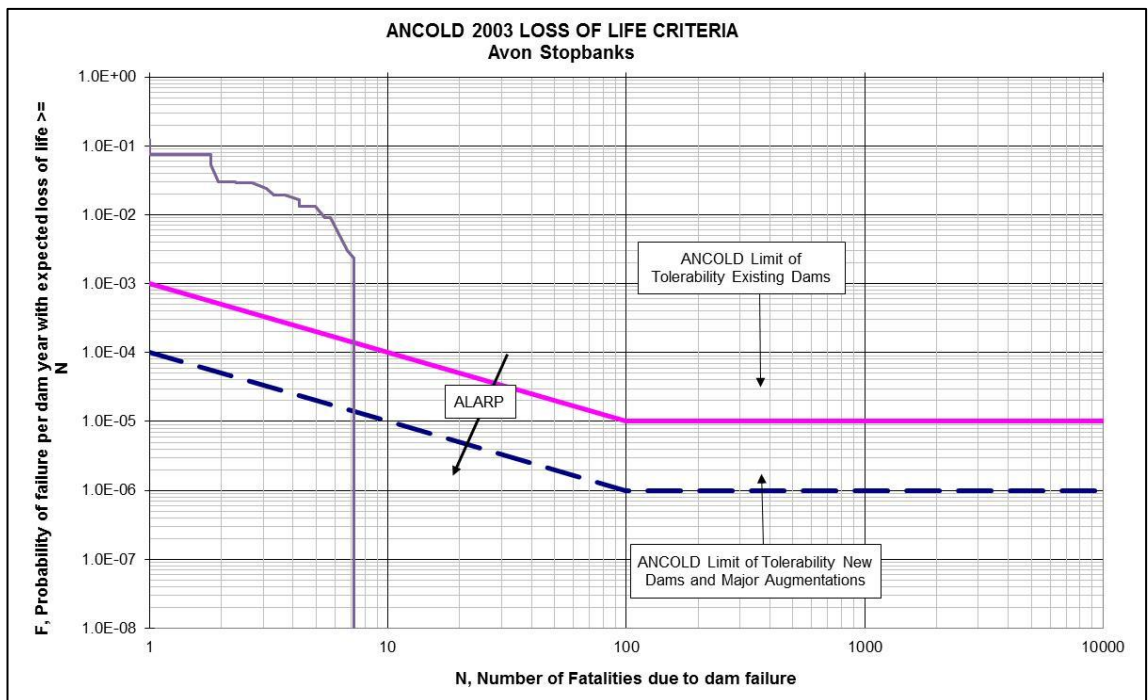
**Figure 5-5 Avon Stopbanks Societal Risk for Floods and Seismic events**

The societal risk was calculated for the Stopbank with the flood and seismic events, as shown on Figure 5-5, which clearly indicates that the risk is above the tolerable limit for which upgrade works are required.

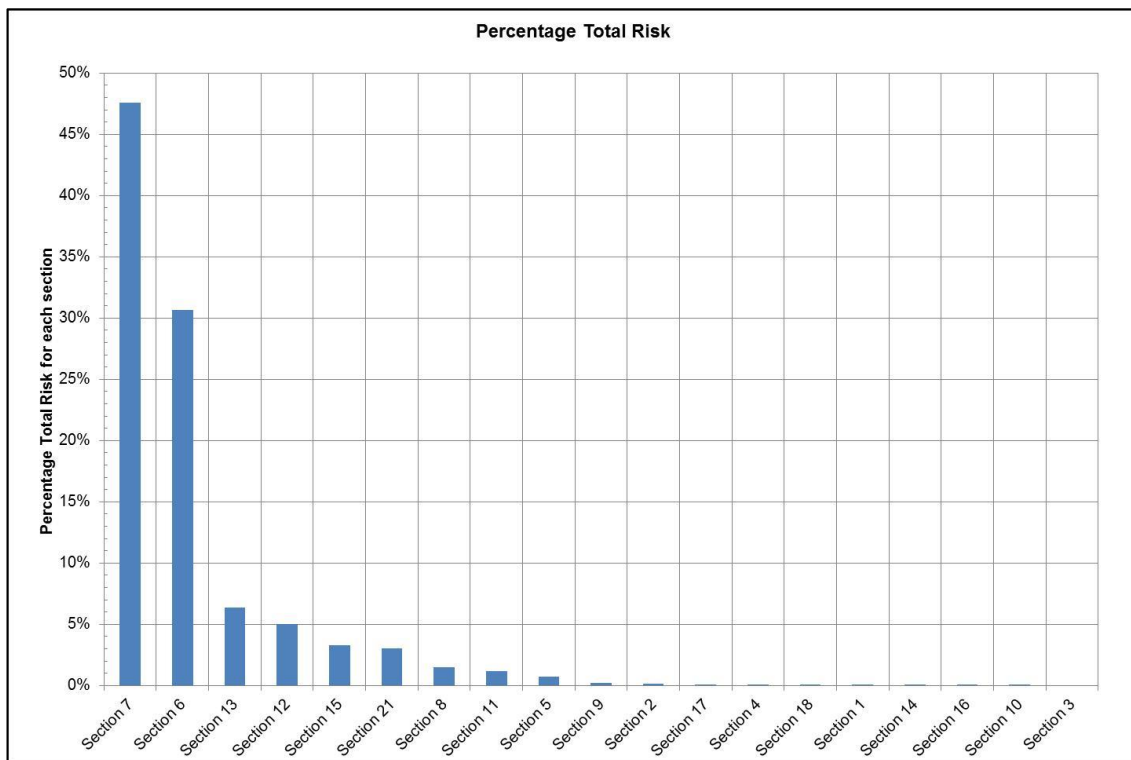
**Figure 5-7 Avon Stopbank Percentage total risk ranked for each section**

The risk analysis results clearly show that the risk is dominated by the flood overtopping with the sections having sandbags contributing the highest proportion of the risk, as shown on Figure 5-7.

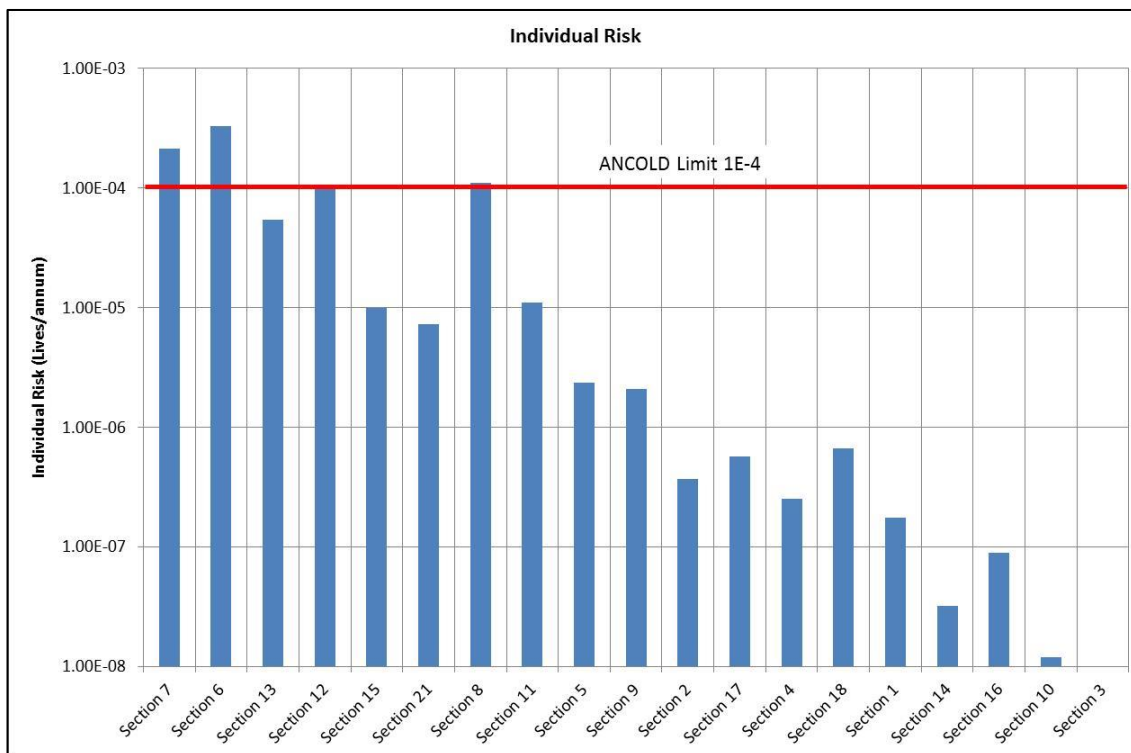
**Figure 5-8 Avon Stopbank Individual Risk**

The Individual risk was calculated for each section, as shown on Figure 5-8, which indicates that Sections 6, 7, 8 and 12 are at or exceed the ANCOLD limit of tolerability of 1E-4.

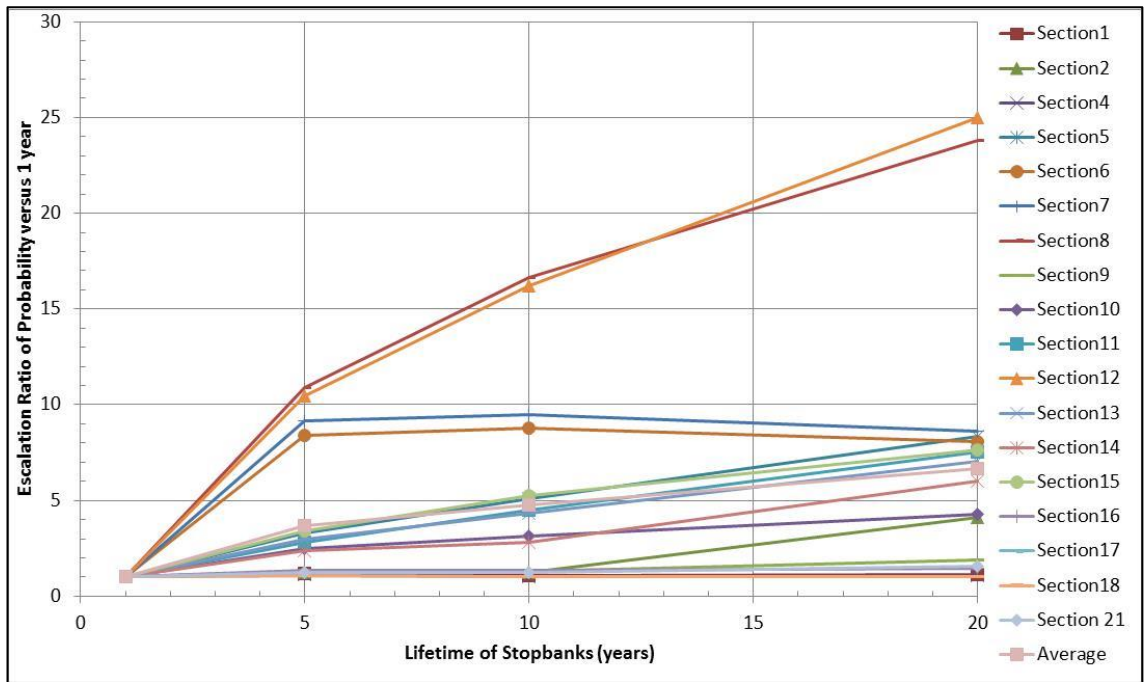
**Figure 5-12 Avon Stopbank Failure escalations factors versus lifetime for Tidal and Seismic Events**

The failure escalations factors versus lifetime for Tidal and Seismic Events, as given on Figure 5-12, show that, in general, the long term likelihood of failure is not significantly increased after the first five years of operation. The long term management options, therefore, include the following:

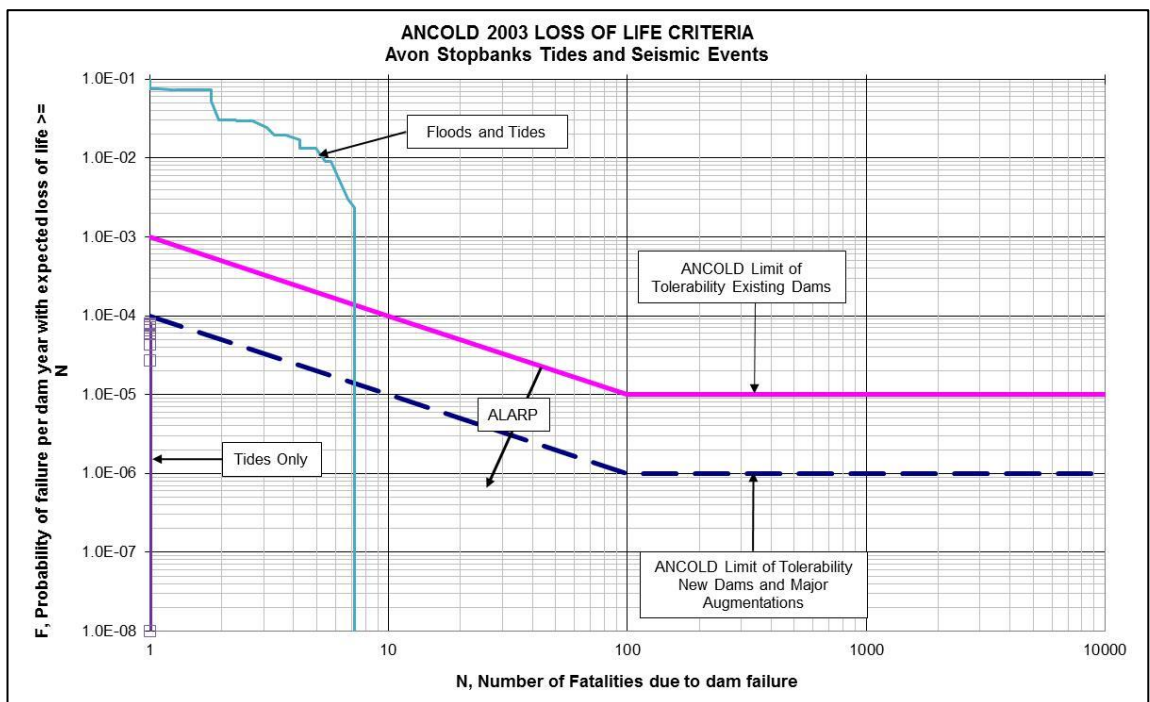
**Figure 5-13 Avon Stopbanks Societal Risk for Tides and Seismic events and Floods and seismic events**

The societal risk was calculated for the Stopbank with the tides and seismic events, as shown on Figure 5-13, which includes the societal risk for floods and seismic events. The figure clearly indicates that the risk is below the tolerable limit for which upgrade works are required to be considered on an ALARP basis.

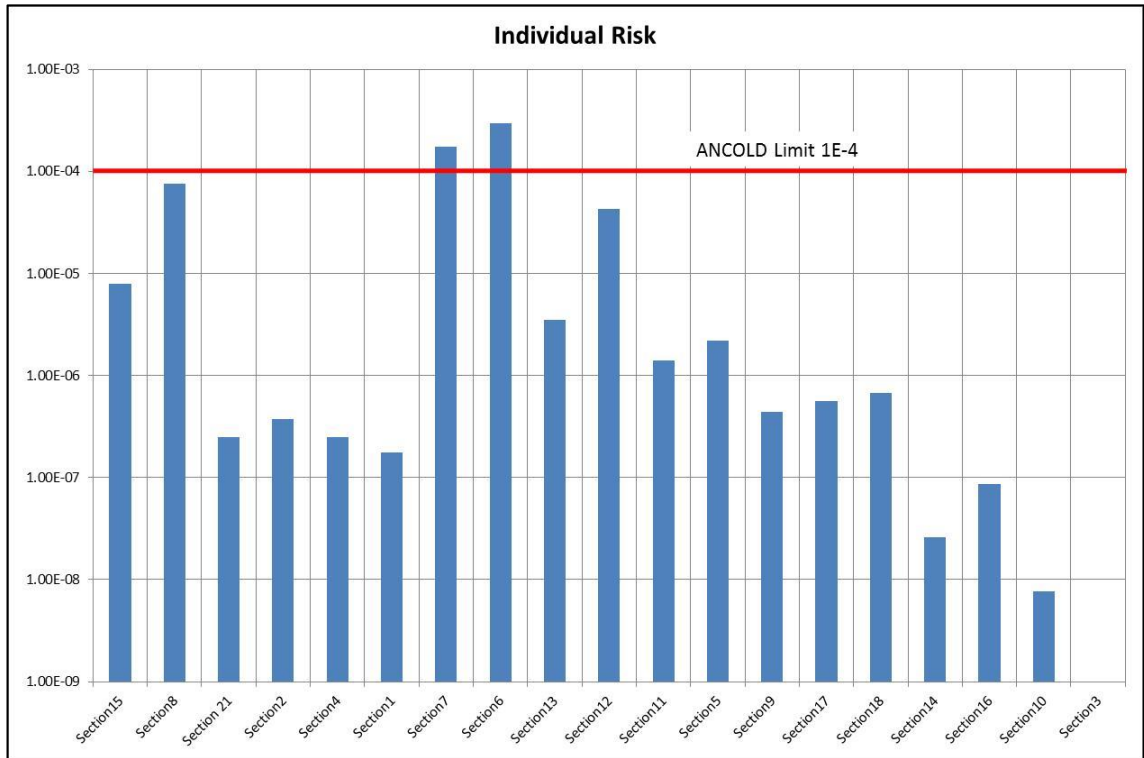
**Figure 5-15 Avon Stopbank Individual Risk for Tides and Seismic events**

The Individual risk was calculated for each section, as shown on Figure 5-15, which indicates that Sections 6, 7 and 8 are at or exceed the ANCOLD limit of tolerability of 1E-4.

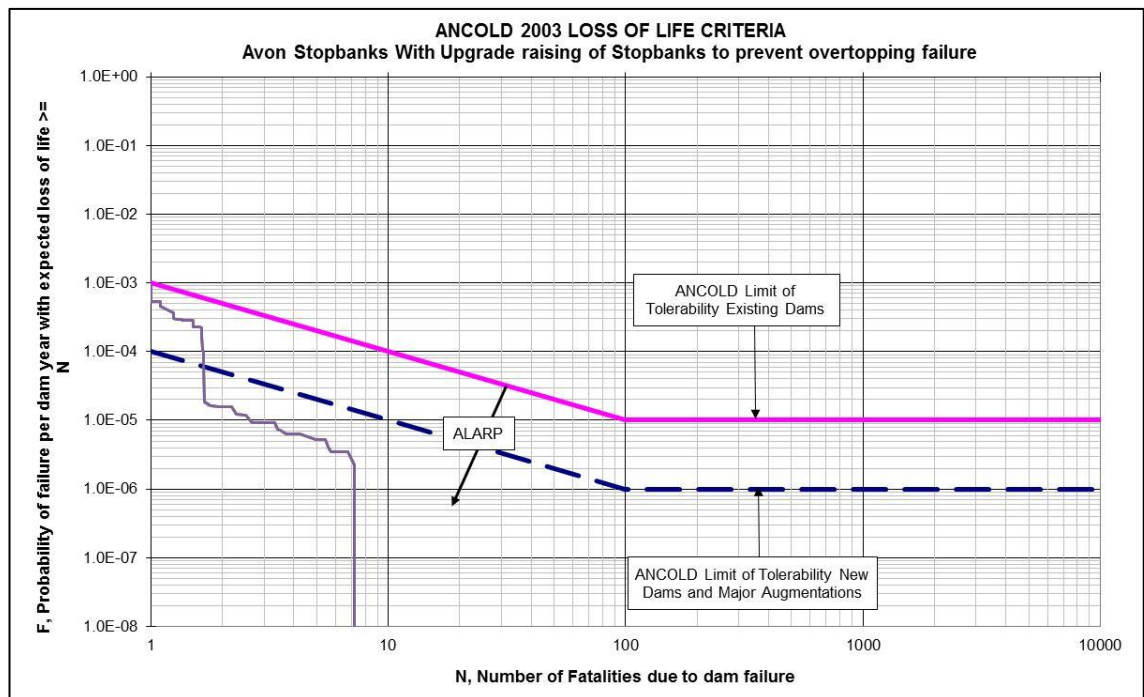
**Figure 5-16 Avon Stopbanks Societal Risk after raising stopbanks to prevent overtopping**

The resulting Societal risk after completion of the upgrade works is as shown on Figure 5-16, which indicates that the risk is reduced to below the ANCOLD Tolerable limit and further upgrade works should be considered based on the ALARP principle.

The upgrade option for raising the embankment reduces the Societal risk below the ANCOLD Tolerable limit, as shown on Figure 5-16 and further upgrade works are to consider the ALARP principle. The individual risk for the raised embankment sections is lowered to below the ANCOLD limit of tolerability for all sections, as shown on Figure 5-17.

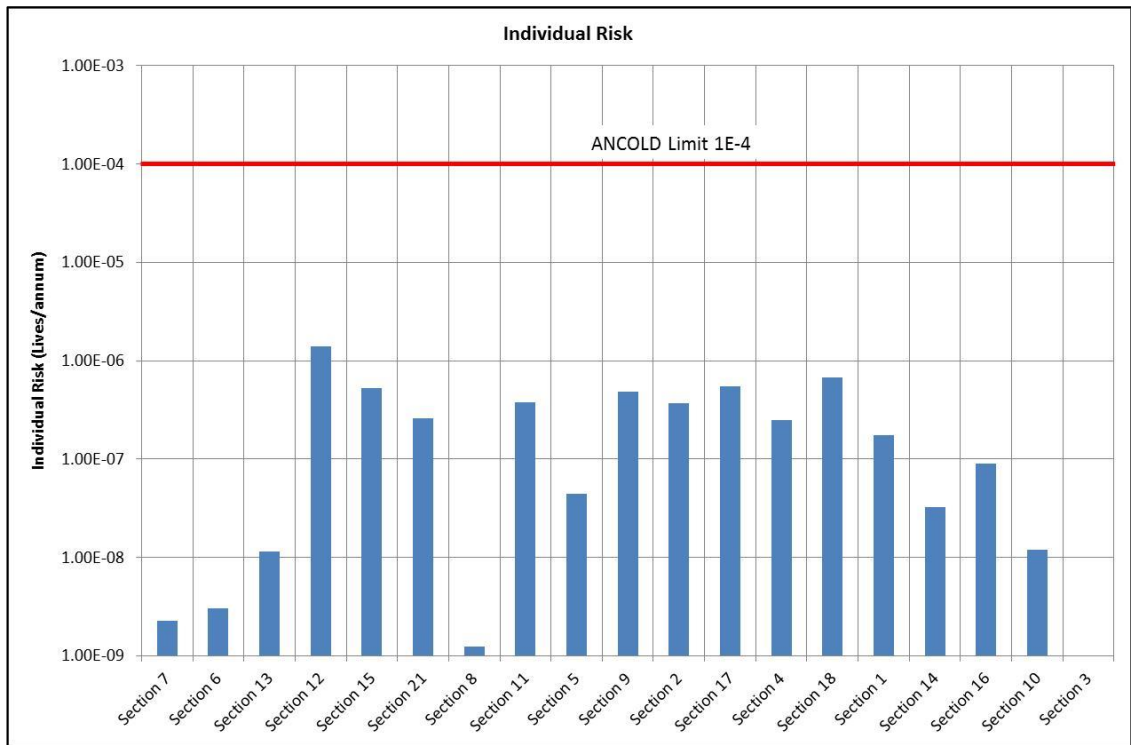
**Figure 5-17 Avon Stopbank Individual Risk for Floods, Seismic and Tidal events after raising stopbanks to prevent overtopping**

The Individual risk is as presented on Figure 5-17 clearly shows that the risk is acceptable.

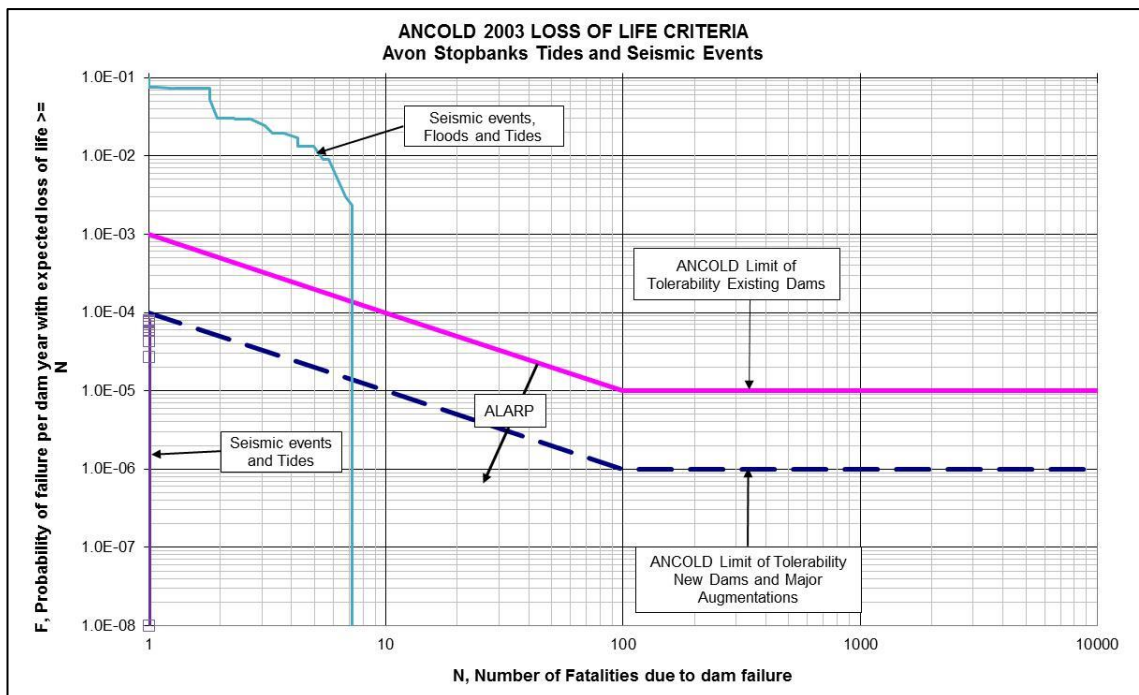
**Figure 6-1 Avon Stopbanks Societal Risk for Seismic events with Tides and Tides and Floods**

- The Societal risk is well in excess of the ANCOLD Tolerable limit for the seismic, floods and tidal events and confirms the need for prevention of overtopping failure of the stopbanks resulting from flood events.
- The Societal risk is acceptable for the Tides and Seismic events, and confirms that remedial works are required to satisfy the As Low As Reasonably Practicable (ALARP) criteria.

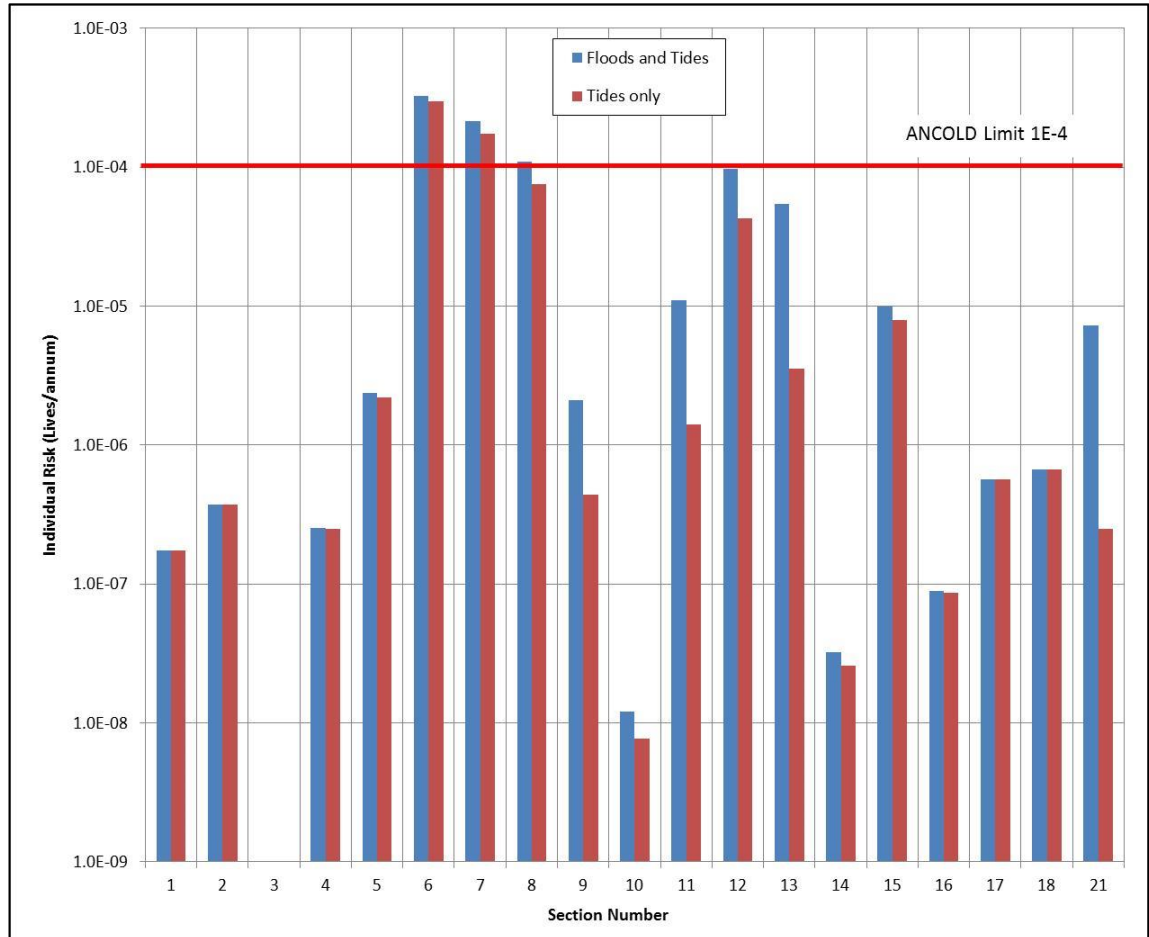
**Figure 6-2 Avon Stopbanks Individual Risk**

The results show a significant escalation in potential failure of the stopbank sections within the next five years of between 8 to 11 for Sections 6, 7, 8 and 12 where sandbags have been used for tidal protection. Section 2, which also has sand bags, has a lower increase of about 1.2 owing to the use of the more substantial sandbags combined with earthfill at this section. The overall increase in failure potential is 3.66 times the annual failure probability within the next 5 years of operation (Table 5-5).

The failure potential and resulting risk for tidal and seismic events is dominated by the seismic deformation resulting in overtopping failure contributing 97.2% of the total risk for the annual events.

The trees within the embankments do not contribute significantly to the failure probabilities or risk.

There are a number of areas where the Stopbank levels are below the design level of RL 11.2 m which exacerbates the overtopping failure resulting from tides or tides and flood events.

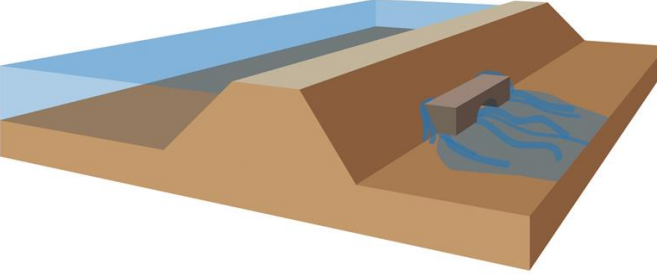
Seepage along stormwater pipes	Hydrological / Flood	<p data-bbox="699 1361 1318 1382">Problem: Seepage water exiting from a point adjacent to a pipe through the embankment</p>

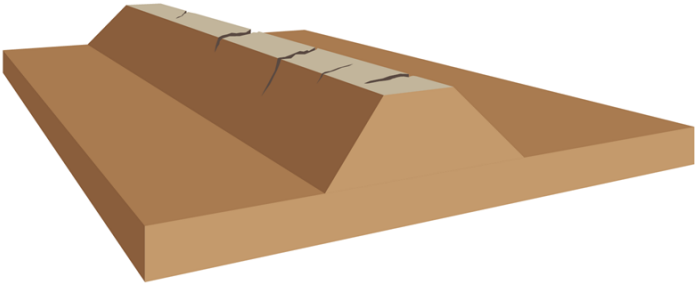
<p><i>Transverse cracking of the wall - Differential movement around pipes</i></p>	<p><i>Earthquake / Flood</i></p>	<p>Problem: Transverse cracking</p>

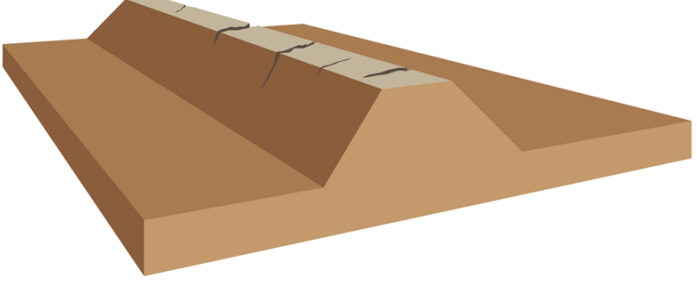
<p><i>Transverse cracking of the wall - Slope failure through weak foundation layers</i></p>	<p><i>Earthquake</i></p>	<p>Problem: Transverse cracking</p>

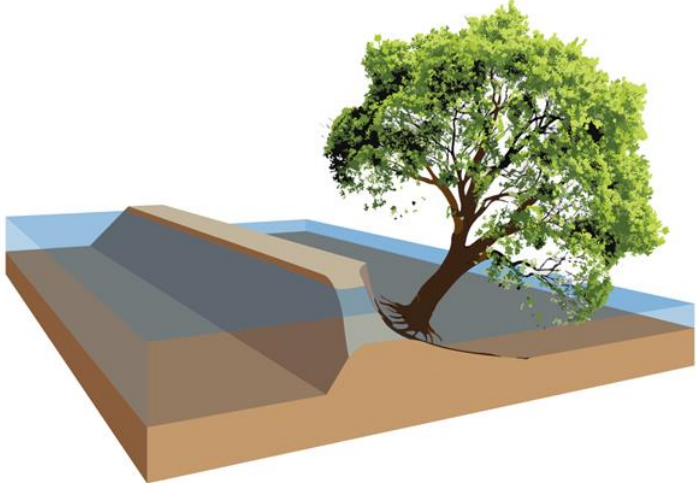
<p>Tree roots rot - Opening Pipes to upstream</p>	<p>Hydrological / Flood</p>	<p>Problem: Vegetation</p>

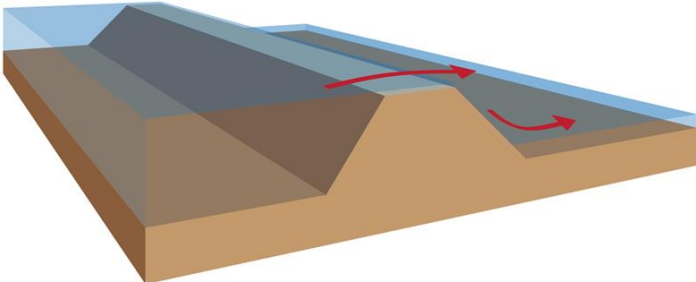
Event	Initiating Event	Schematic Drawing
<b>Overtopping</b>		
<p>Loss of Freeboard - Failure of Sandbags</p>	<p>Earthquake</p>	<p>Overtopping</p> <p>Problem: Floodwater overtopping the embankment</p>

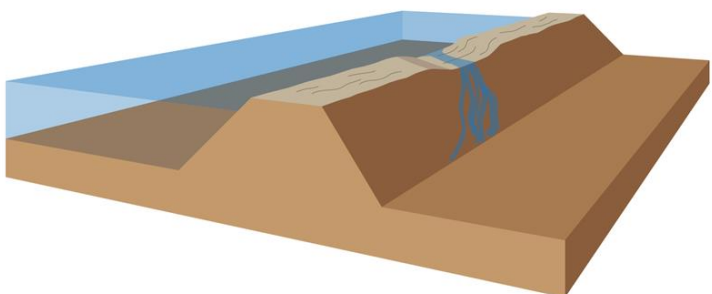
<p>Loss of Freeboard - Slumping (stopbank or foundation)</p>	<p>Flood</p>	
<p>Overtopping during extreme floods causing lack of freeboard (settlement) - Sandbag deteriorates</p>	<p>Hydrological / Flood</p>	<p>Problem: Low area or dip in crest</p>
